BUREAU OF SHIPS GROUP TECHNICAL INSPECTION REPORT

U.S.S. INDEPENDENCE (CVL22)

TEST ABLE

VOLUME 4 OF 4

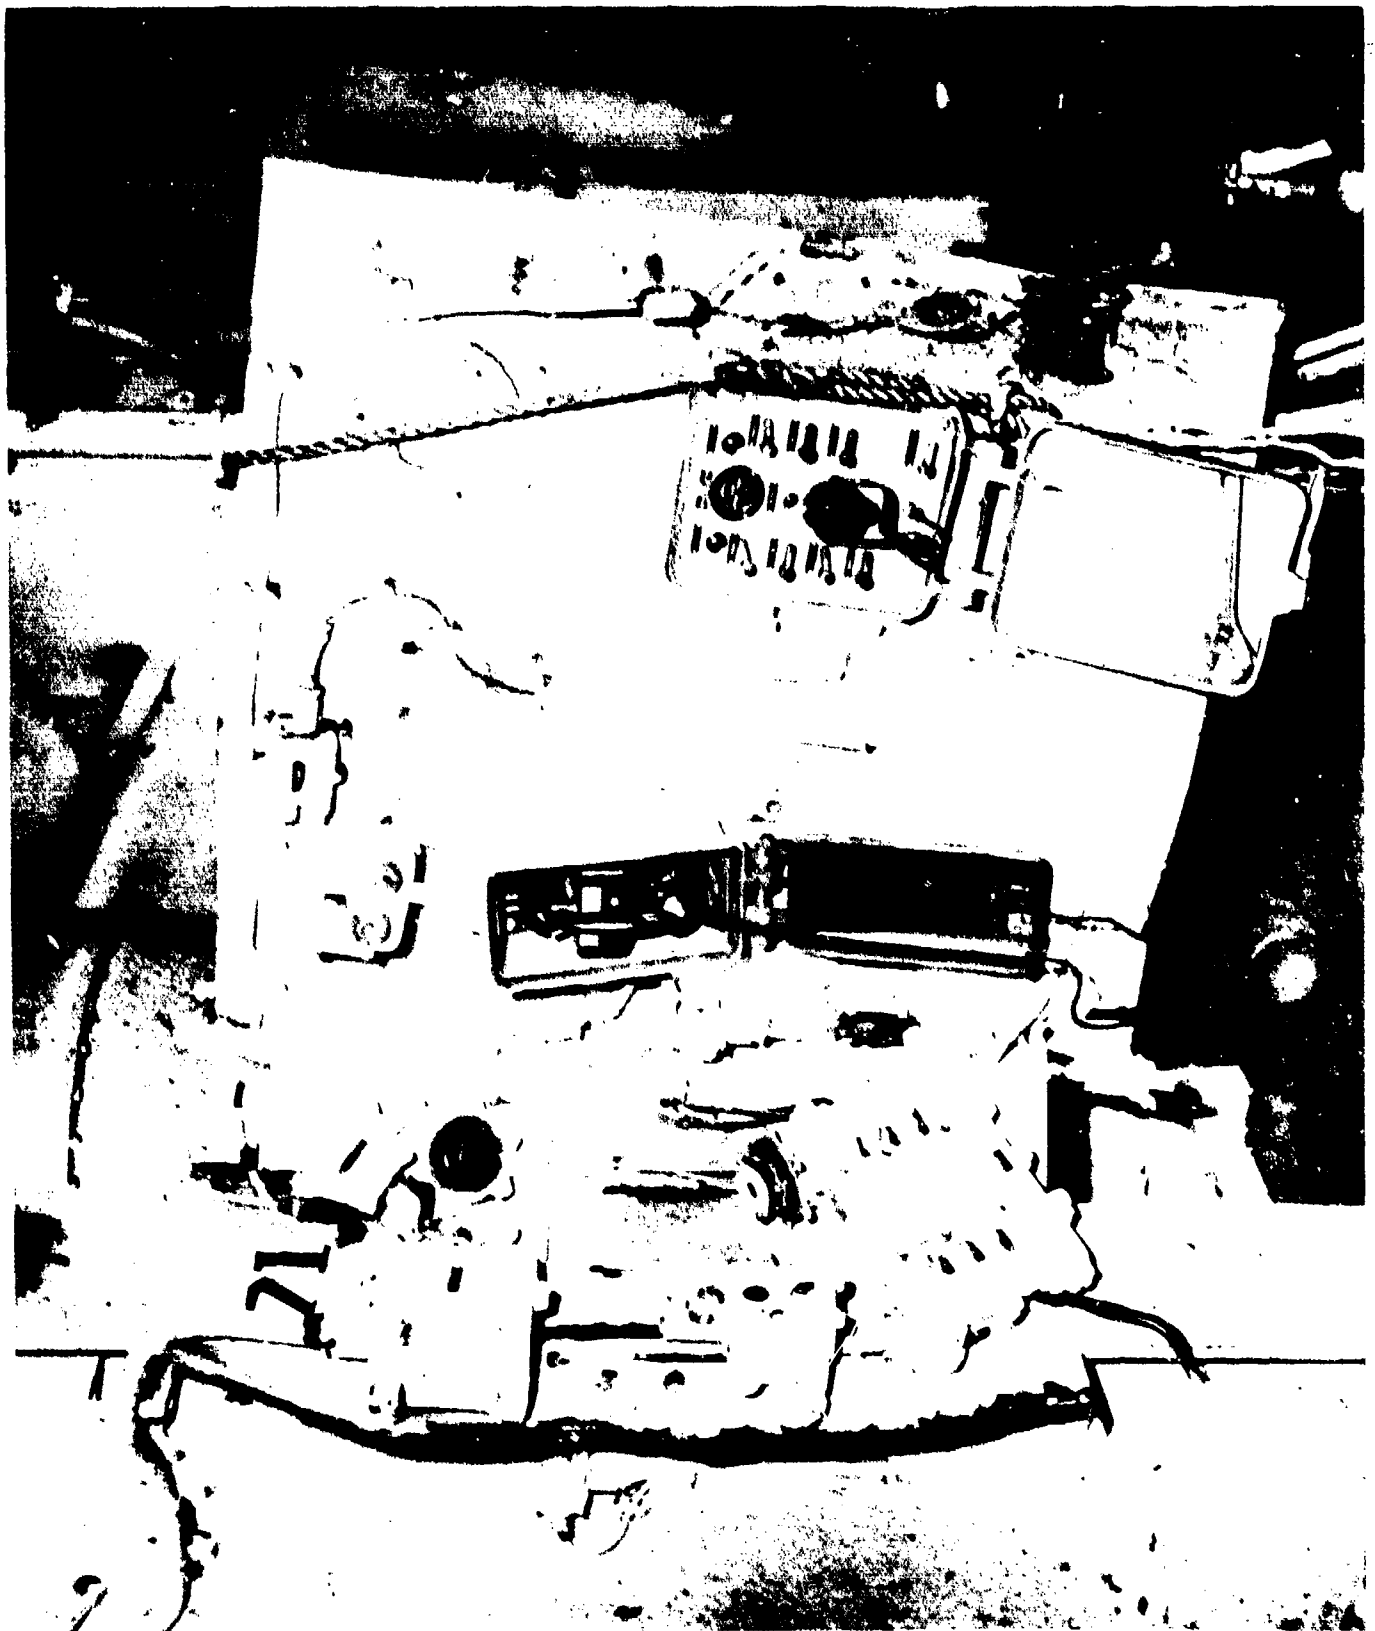
AA-CR-82-1917-6. Communication and control equipment at quarter deck station, frame seventy one starboard side hangar space. View looking starboard and aft.

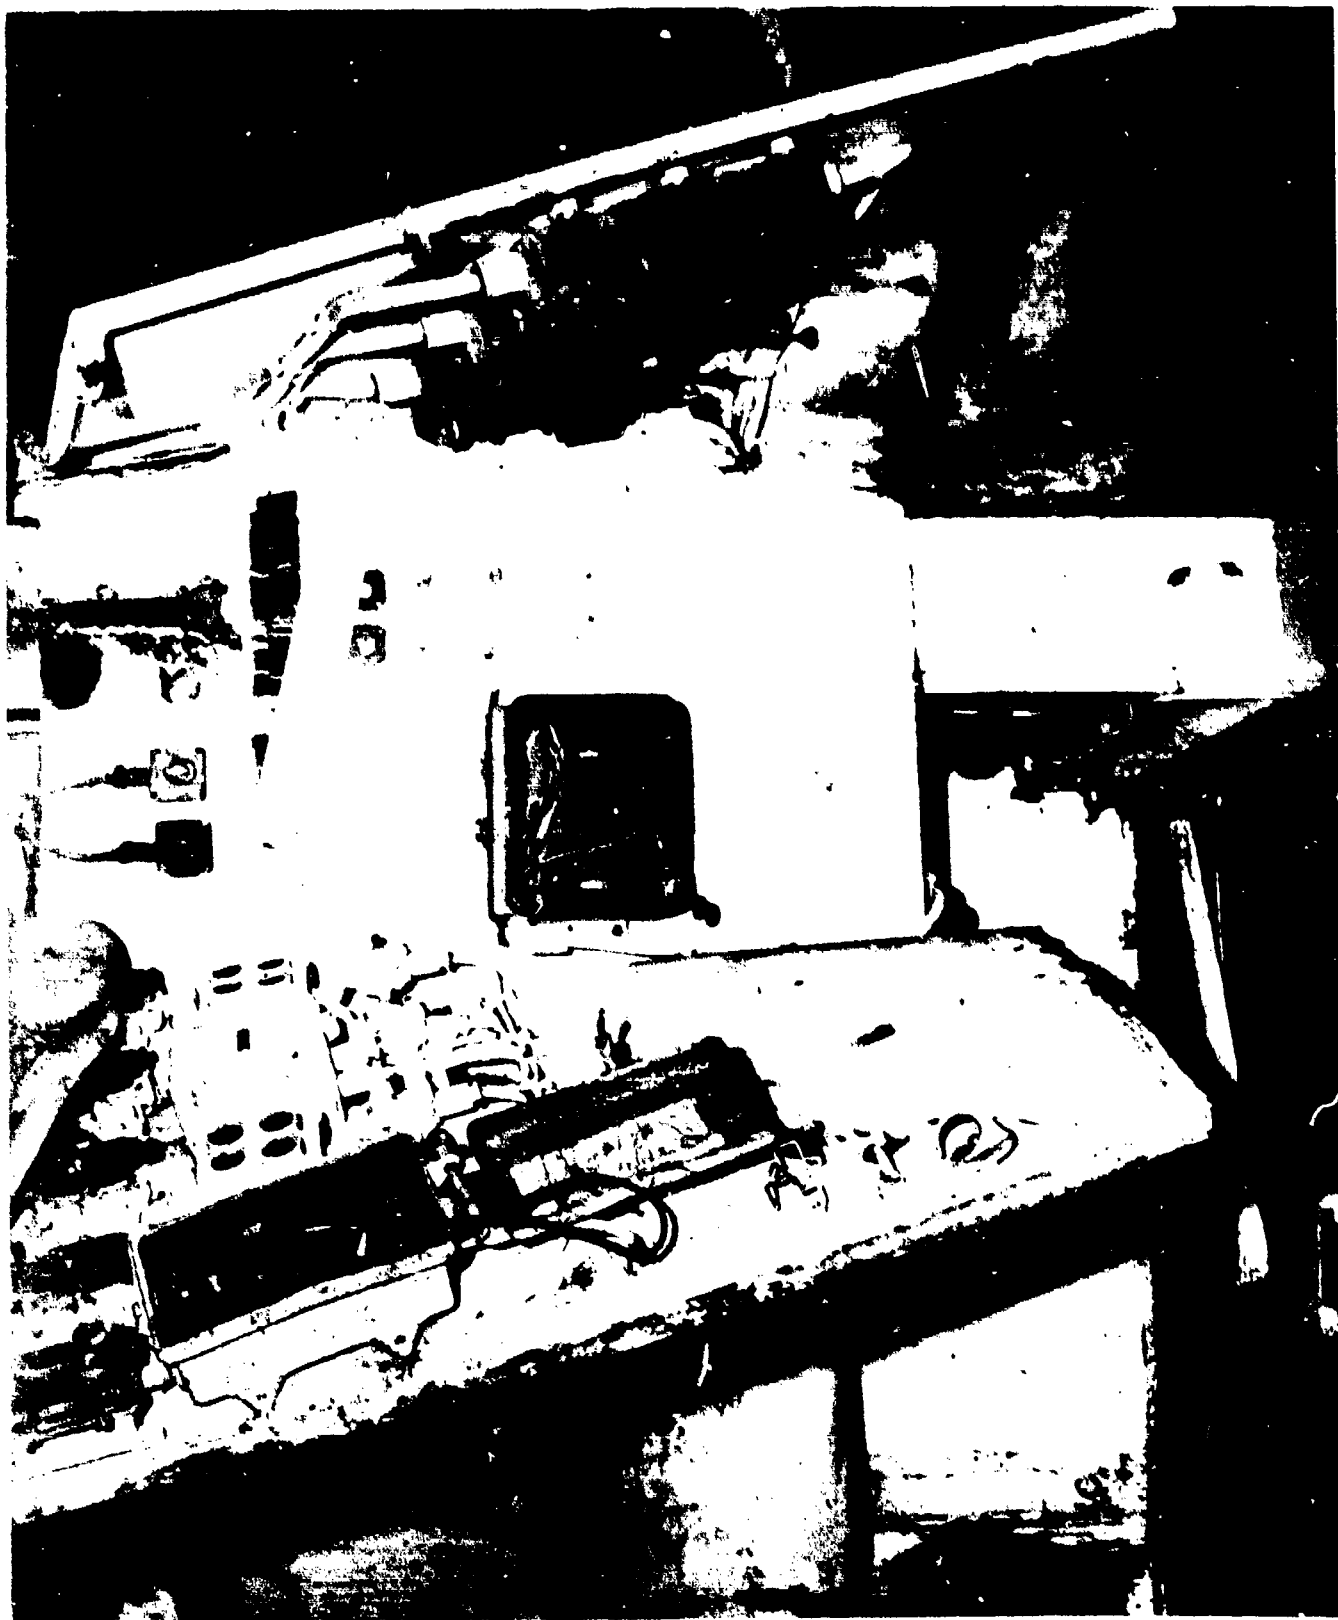
AA-CR-82-1917-7. Water curtain control switches, communication equipment and gasoline trunk ventilation controls frame 80 starboard side hangar space, view looking to starboard.

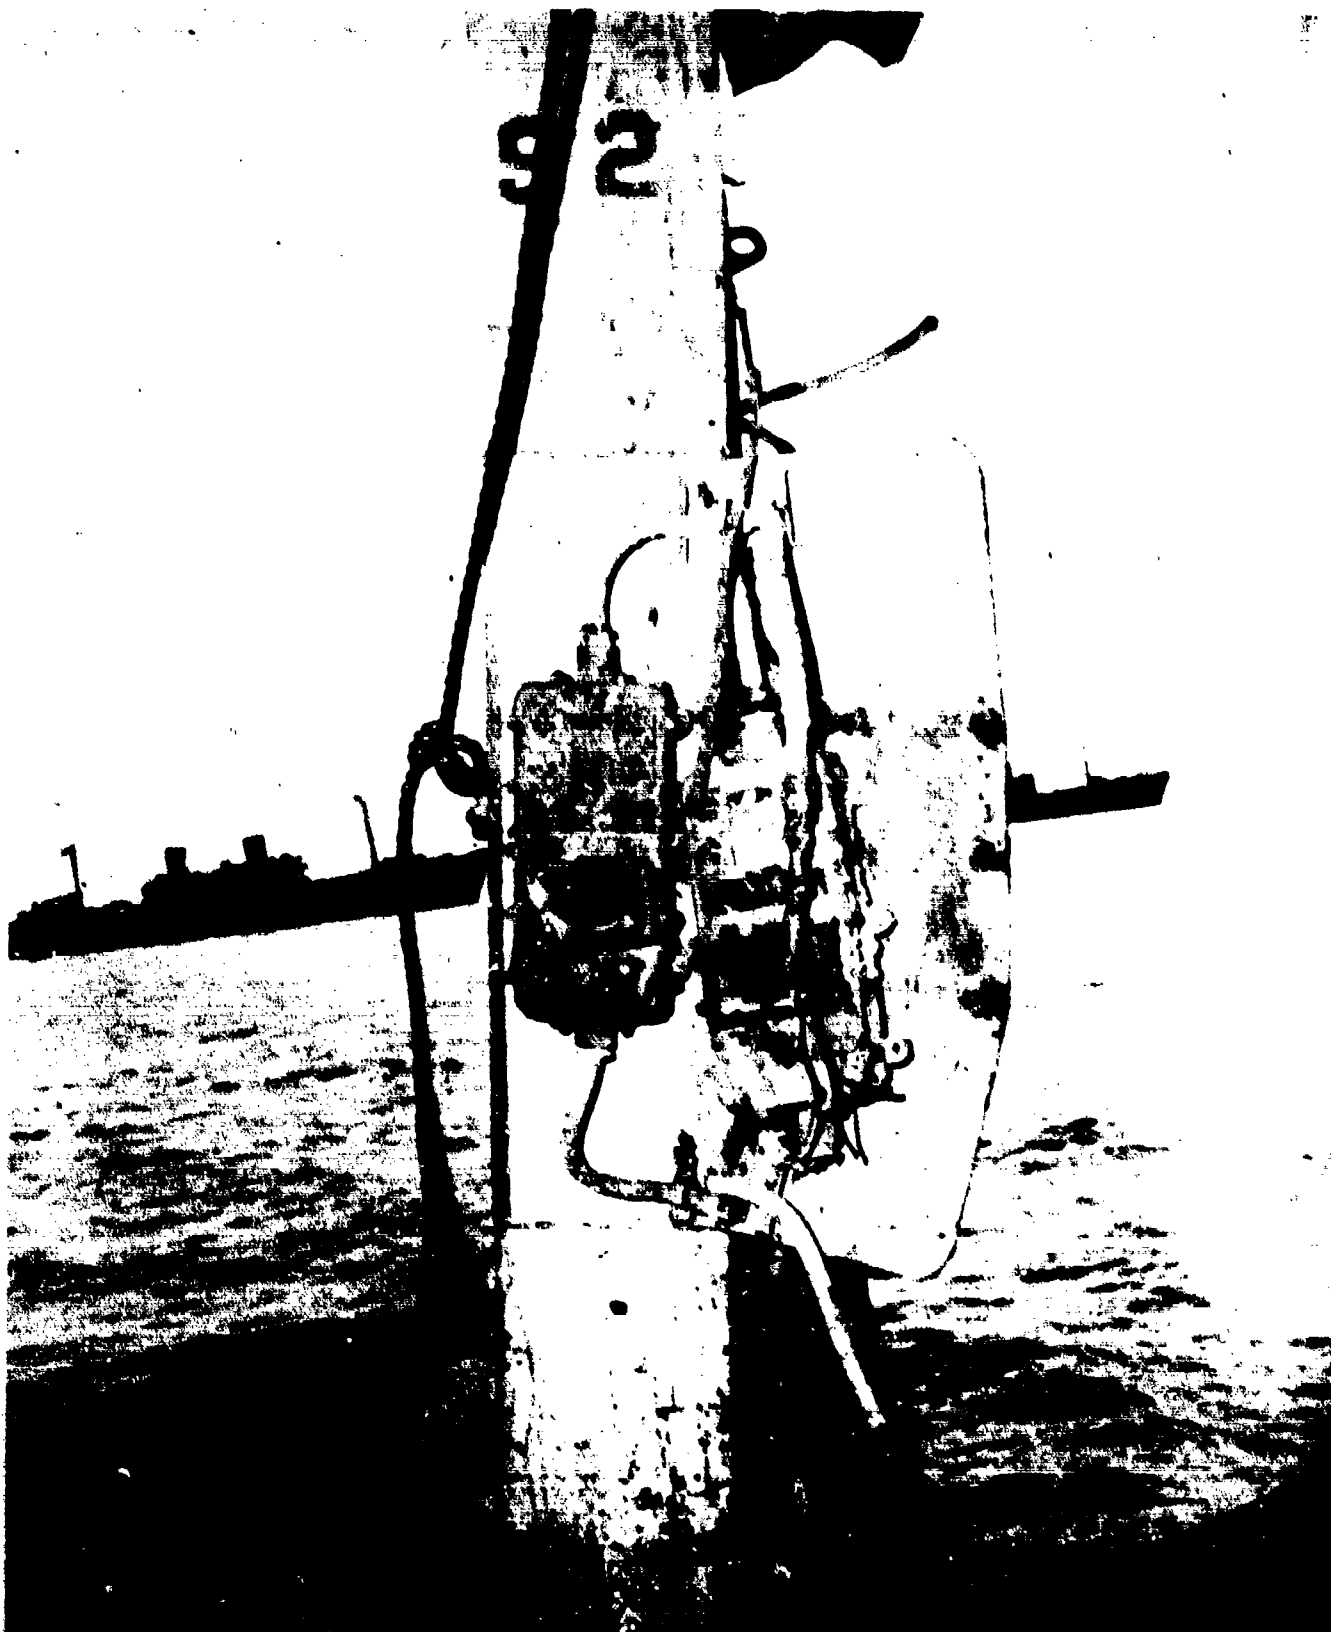
AA-CR-82-1918-5. Damage to water curtain control switches, located frame 8 port side hangar space. One switch missing. View looking outboard.

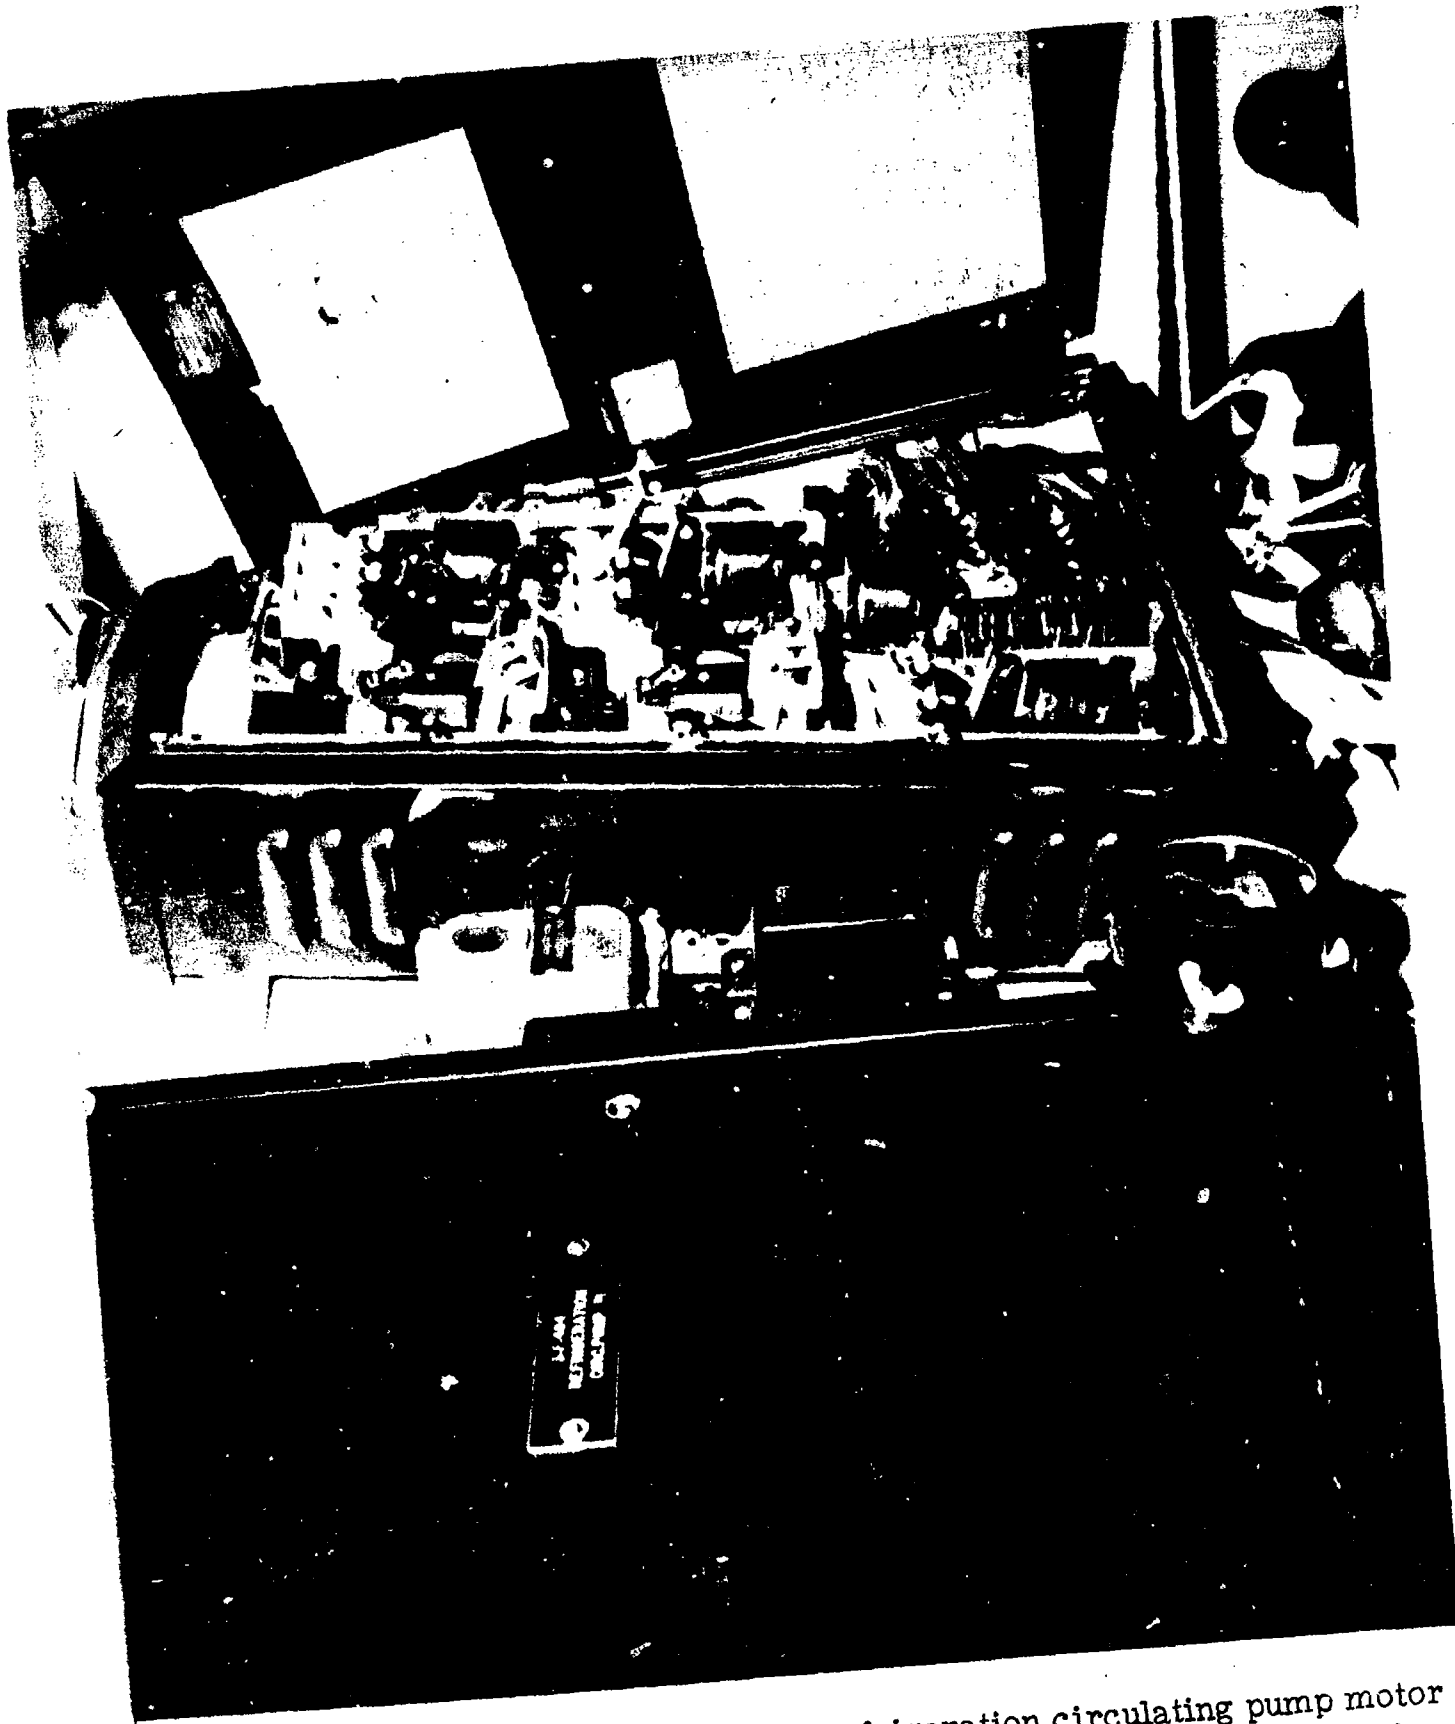
AA-CR-82-1916-12. Controller for refrigeration circulating pump motor #2 located on bulkhead 126 port side 3rd deck in ice machine room. View looking aft.

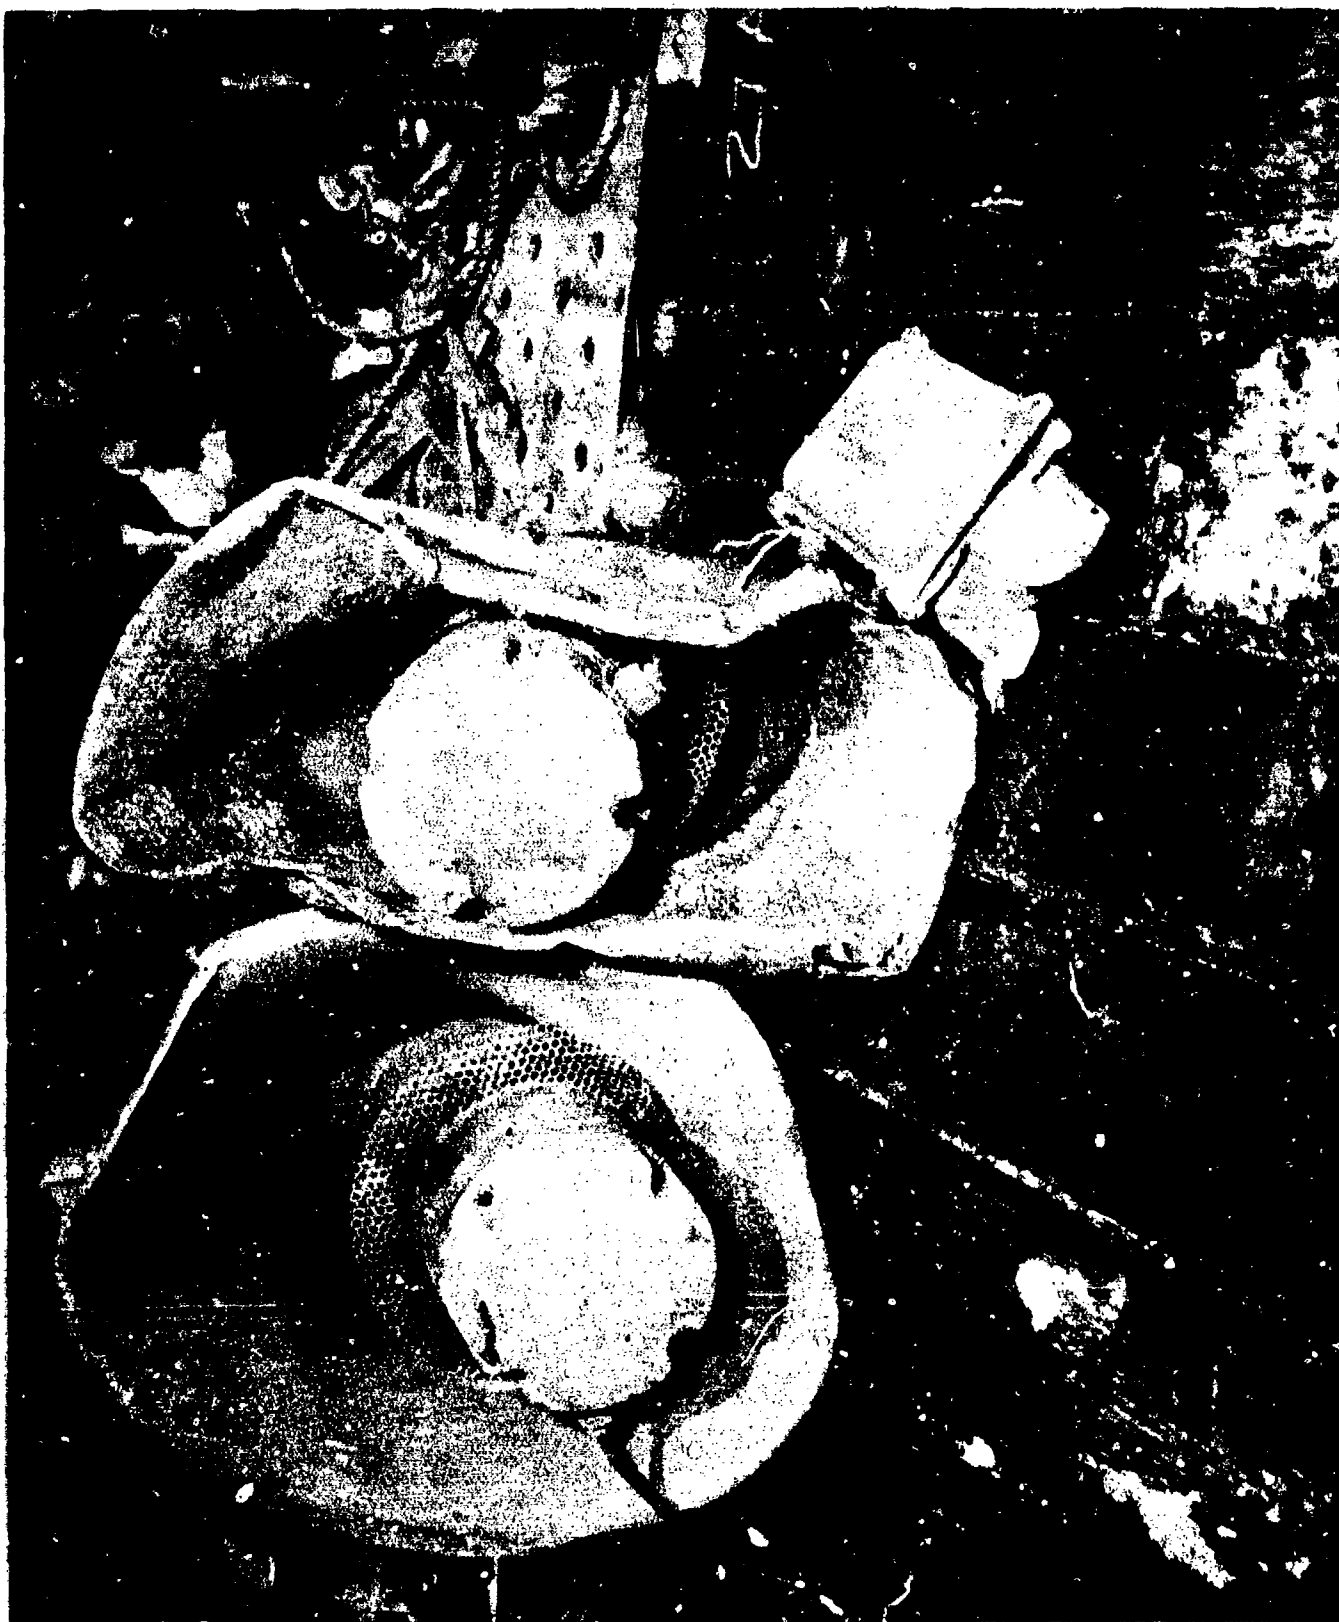
AA-CR-62-1880-10. Two 3MC reproducers laying on flight deck, which were broken loose from foundations on port bulkhead island structure above flight deck, overlooking and down to starboard.
